CITY OF BALTIMORE SMOKE TESTING OBSERVATION SUMMARY LOW LEVEL SEWERSHED

BALTIMORE CITY PROJECT 1029 REI/DRAYCO

Unique Test ID: 585 Date: 09/02/2008 Basin: LL - 44 Manhole ID: S17M_025MH
Defect No: OB01 Supervisor: E.R. Crew: 04 Dye Test Recommended: N

Location: 400 MILLINGTON AVE.

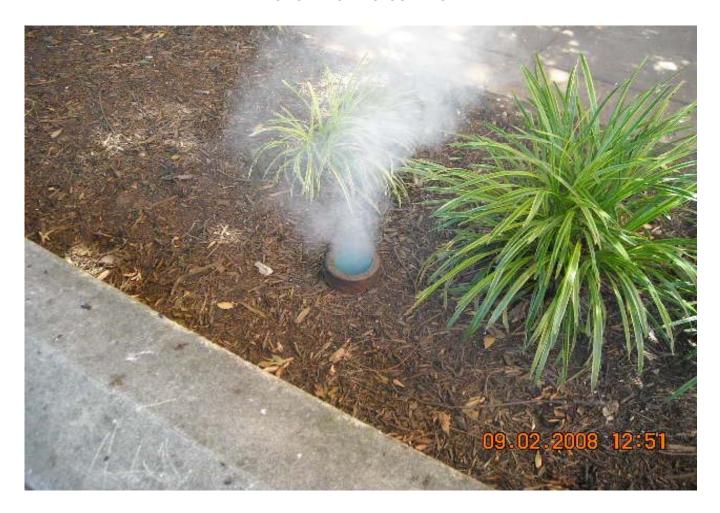
Photograph No: OB01-01 Filename: 1029-585_OB01-01.jpg

Source Type: 03 Cleanout Sector: 02 Private

Location: 14 Other Severity: 03 Moderate Drainage Area: 1

Comments: ABOVE GRADE CLEANOUT WITHOUT CAP IN FLOWER BED.
